**DELINEATION OF WATERS OF THE UNITED STATES AND
BIOLOGICAL INVENTORY, 7.5± ACRE WELLAND STUDY
AREA, BROWNS VALLEY IRRIGATION DISTRICT
TAILWATER RECAPTURE PROJECT, LOCATED WITHIN
PORTIONS OF SECTIONS 21, 22, 28, AND 29, TOWNSHIP 16
NORTH, RANGE 5 EAST MDM. BROWNS VALLEY USGS
QUADRANGLE, YUBA COUNTY, CALIFORNIA 95918**

Update: March 8, 2013

**Browns Valley Irrigation District
Attn: Walter Cotter, General Manager
9370 Browns Valley School Road
Browns Valley, CA 95918**

**Marcus H. Bole & Associates
104 Brock Drive
Wheatland, CA 95692**

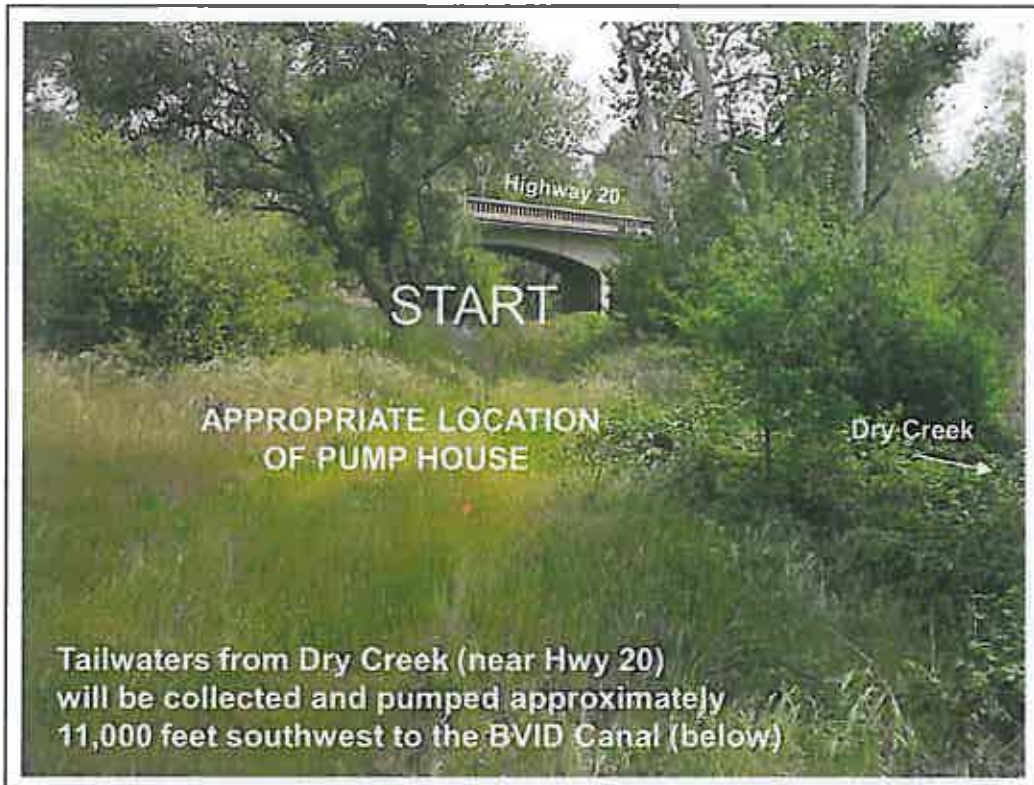
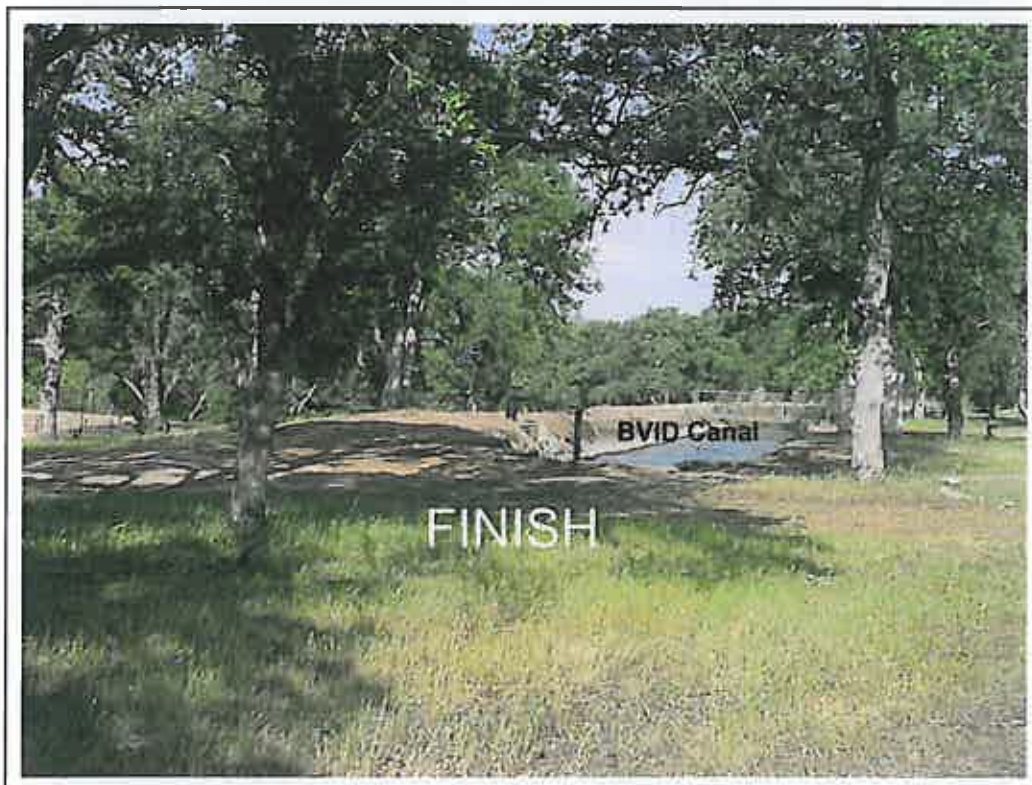
PLATE: 1

SITE: Dry Creek Tailwater Recapture Project
ITEM: Start & End Points
DATE: April 29, 2008

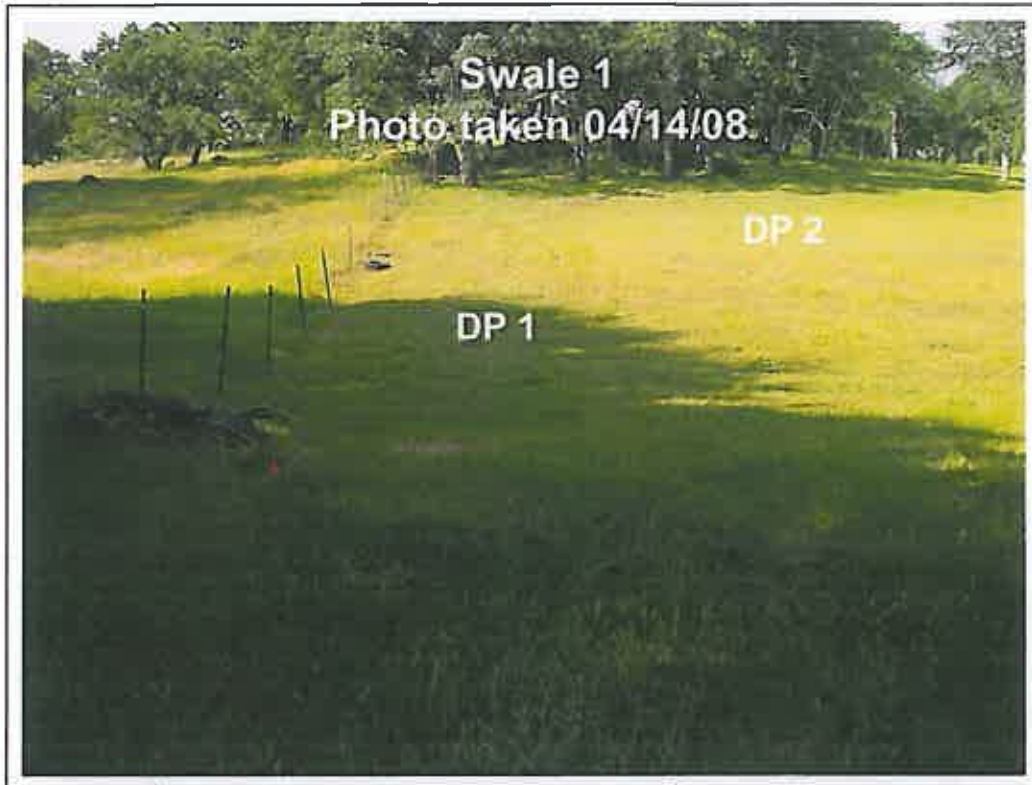
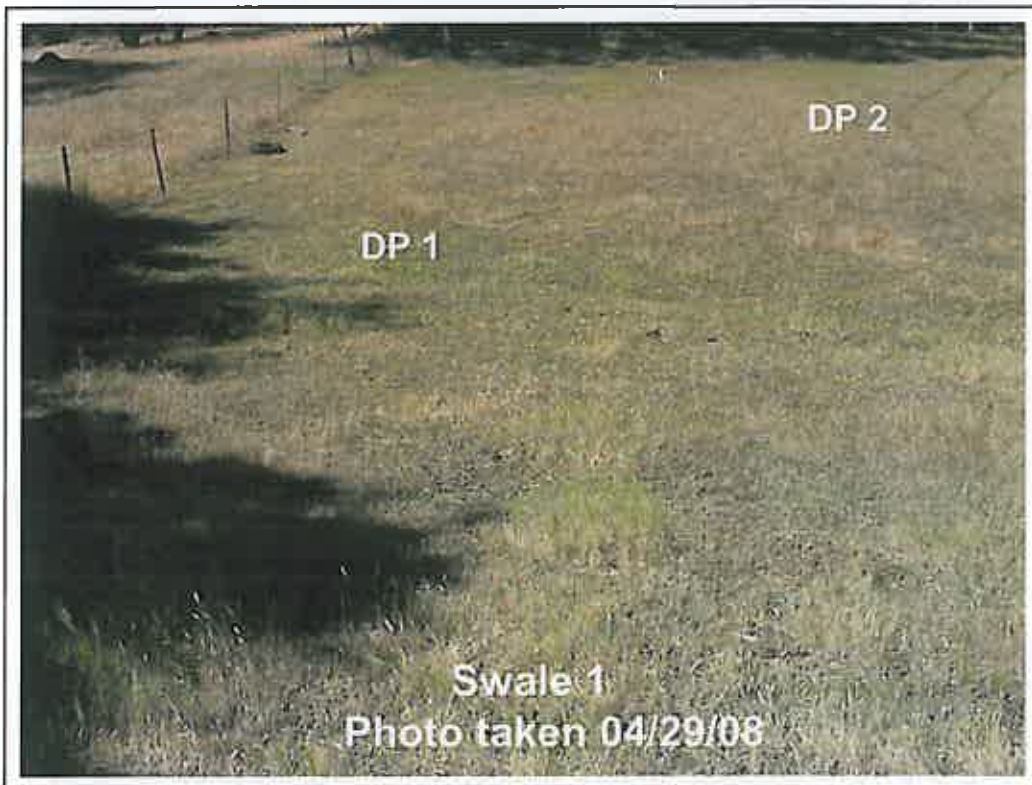
SITE: Dry Creek Tailwater Recapture Project
ITEM: DATA POINTS 1 & 2, Swale 1
DATE: April 29, 2008 PLATE: 2

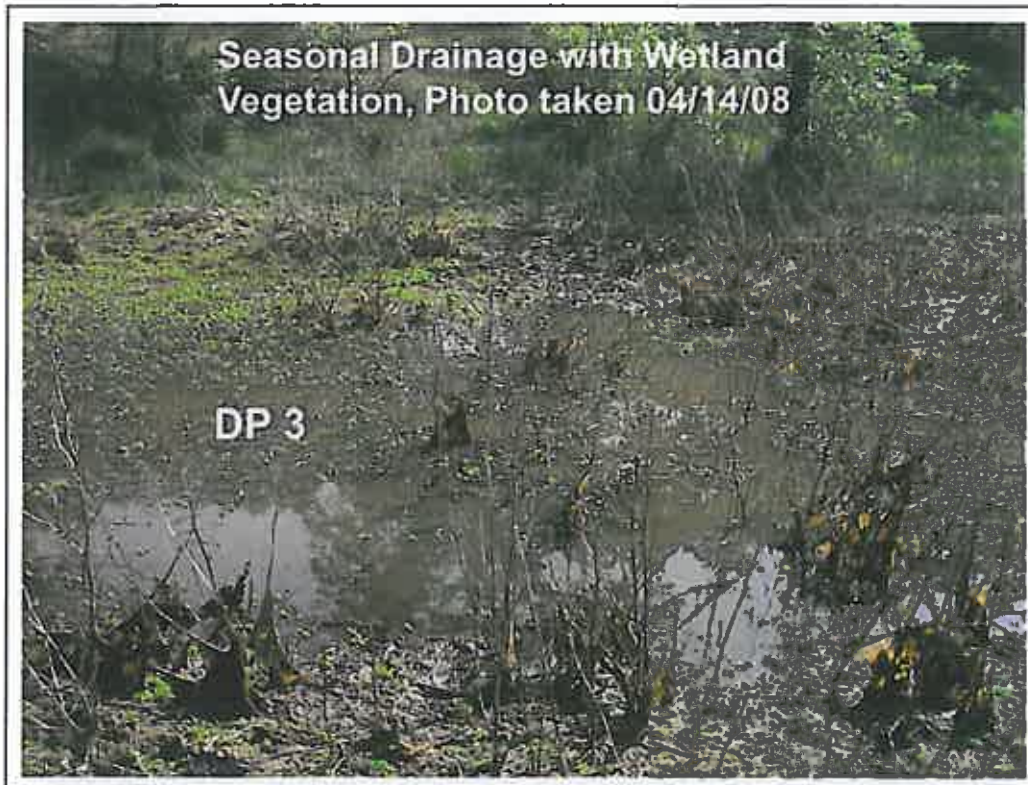
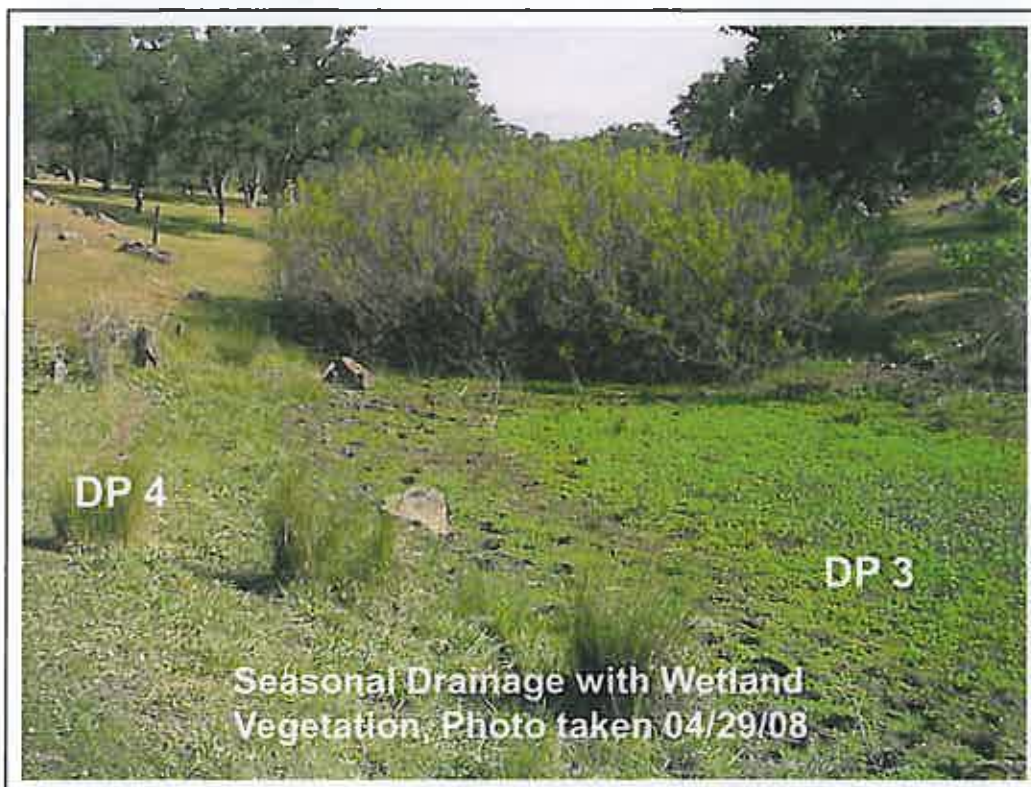
SITE: Dry Creek Tailwater Recapture Project
ITEM: DATA POINTS 3 & 4, Drainage
DATE: April 29, 2008 **PLATE: 3**

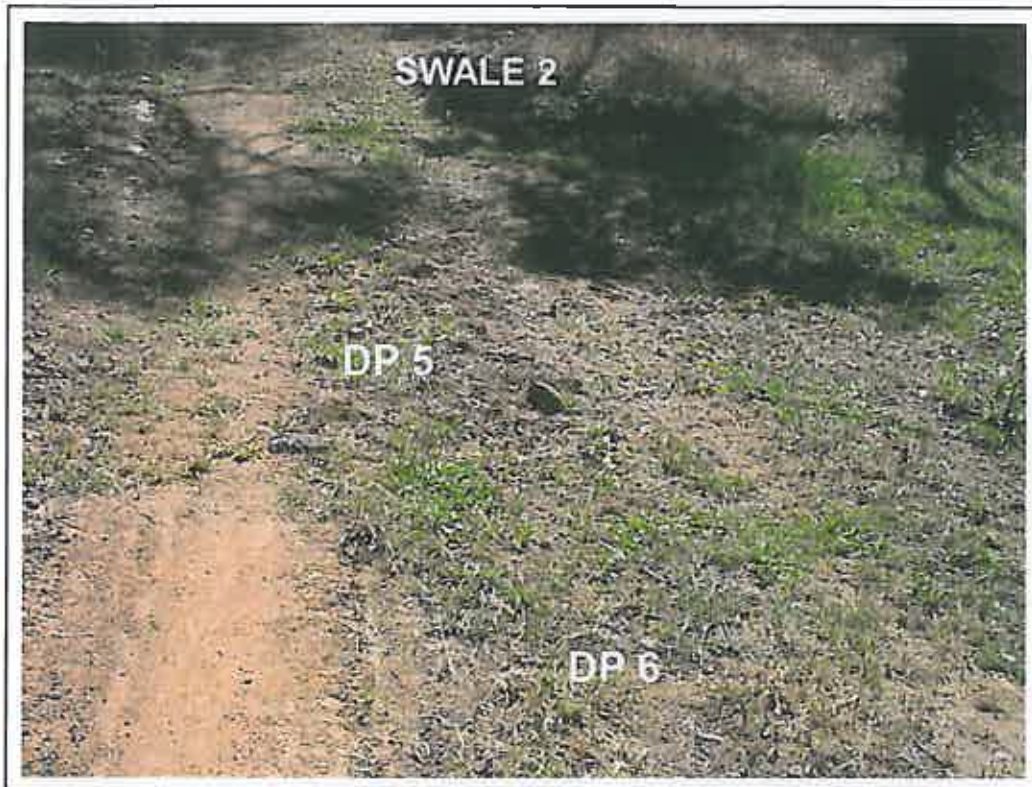
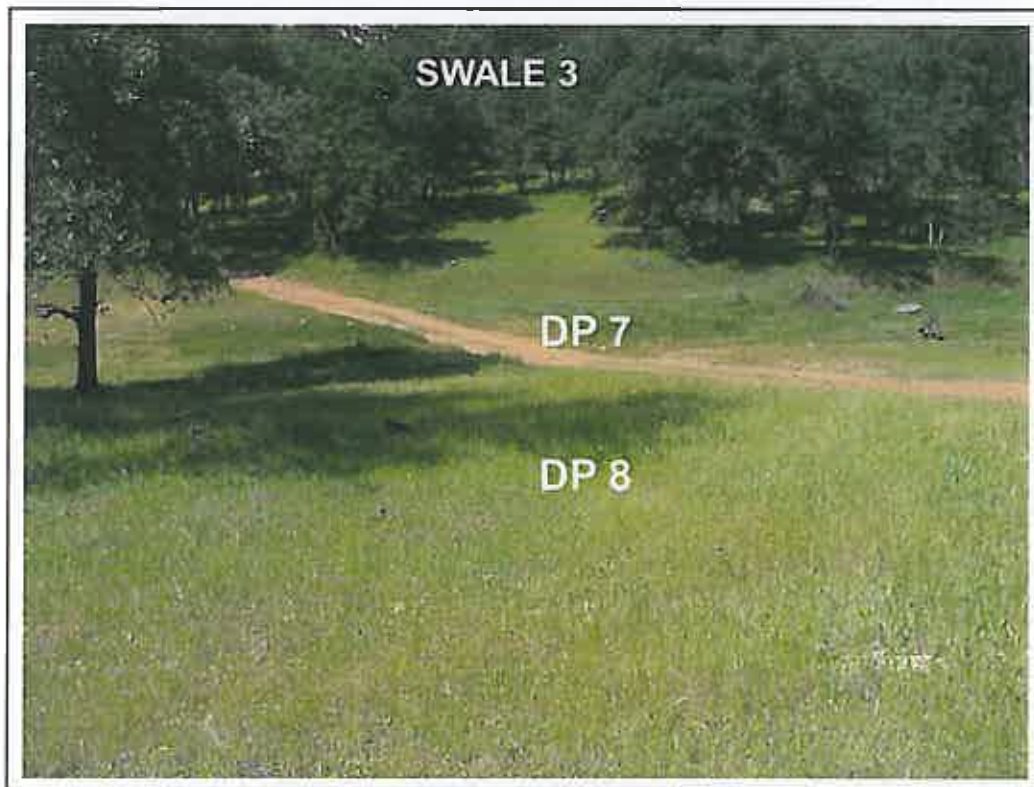
SITE: Dry Creek Tailwater Recapture Project
ITEM: DATA POINTS 5/6 & 7/8, Swales
DATE: April 29, 2008 **PLATE: 4**

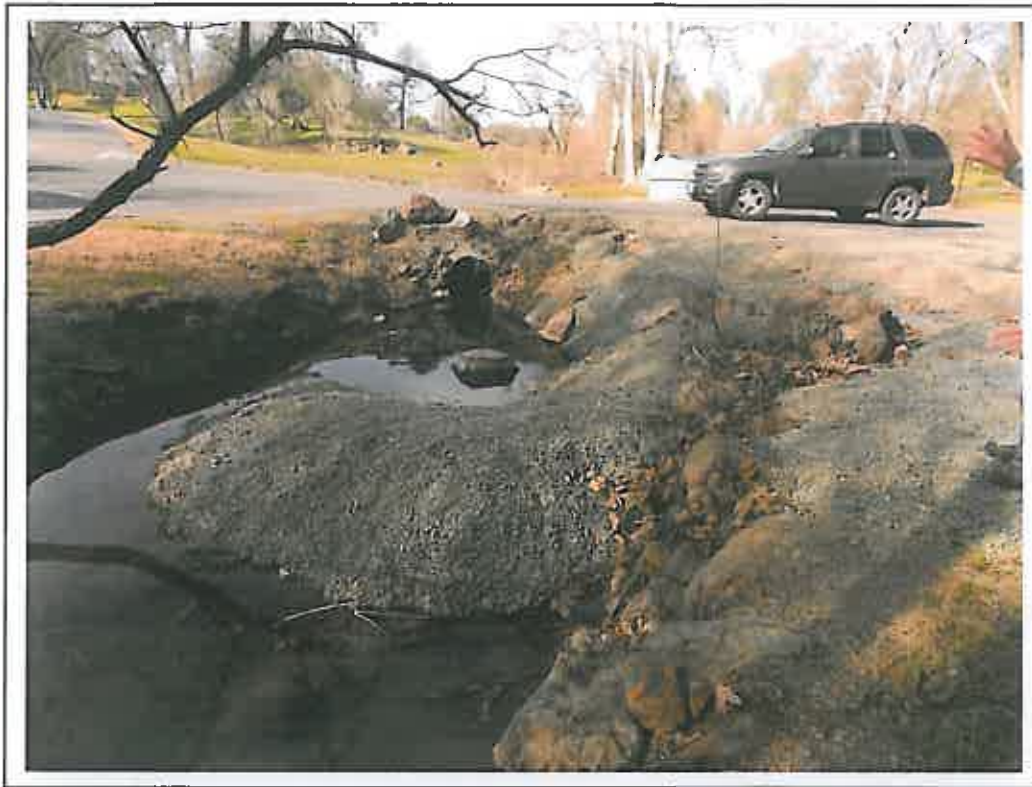
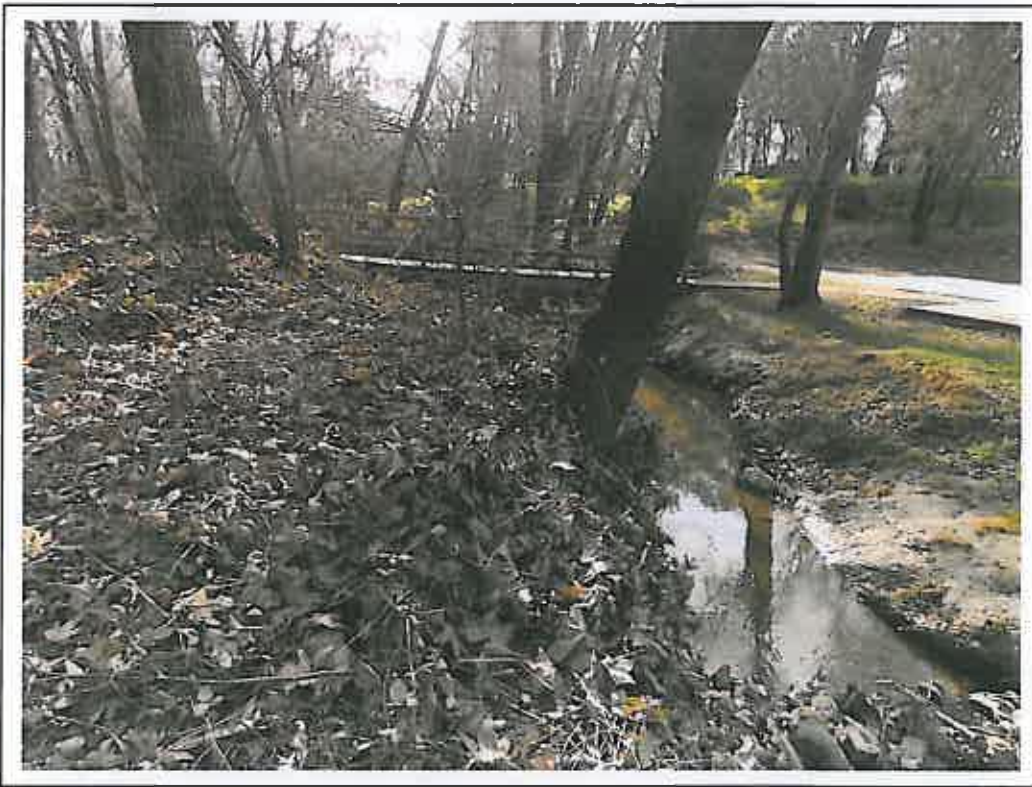
SITE: Dry Creek Tailwater Recapture Project
ITEM: Data Point 9, Seasonal Creek
DATE: February 27, 2013 **PLATE: 5**

In accordance with *Final Sacramento District Nationwide Permit Regional Conditions for California, excluding the Lake Tahoe Basin*, trenching under the seasonal swales, seasonal creeks and Dry Creek will be sealed with suitable material as approved by the Corps of Engineers.

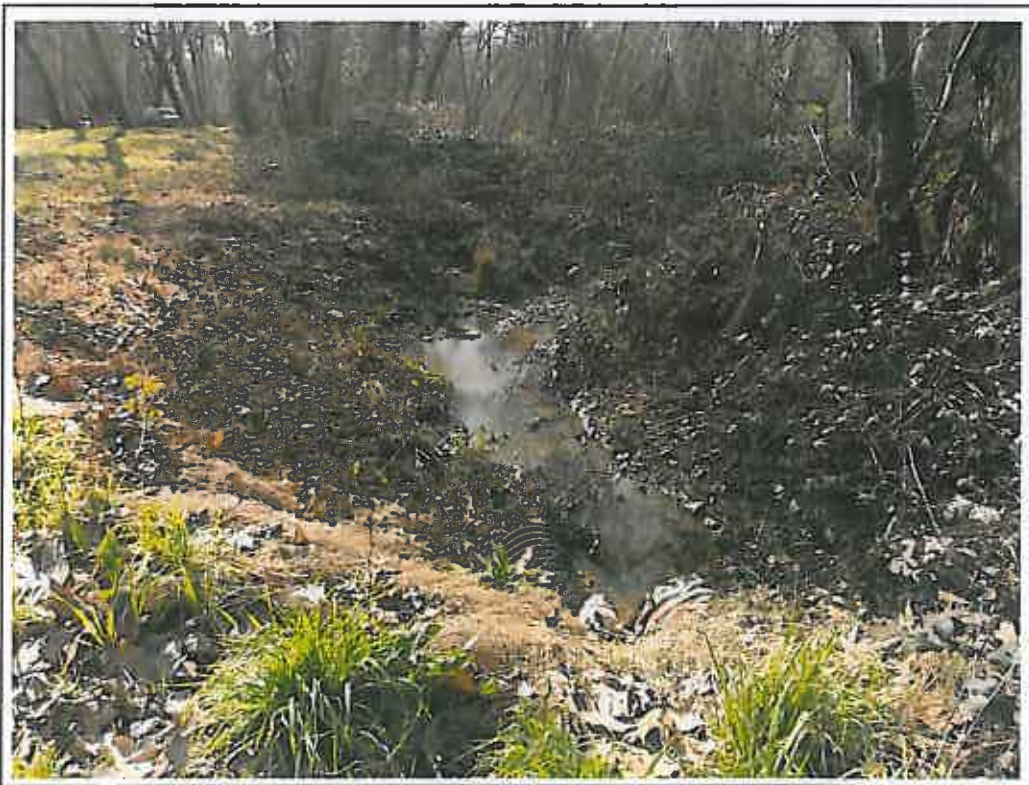
SITE: Dry Creek Tailwater Recapture Project
ITEM: Data Point 10, Culvert Replacement
DATE: February 27, 2013 **PLATE: 6**

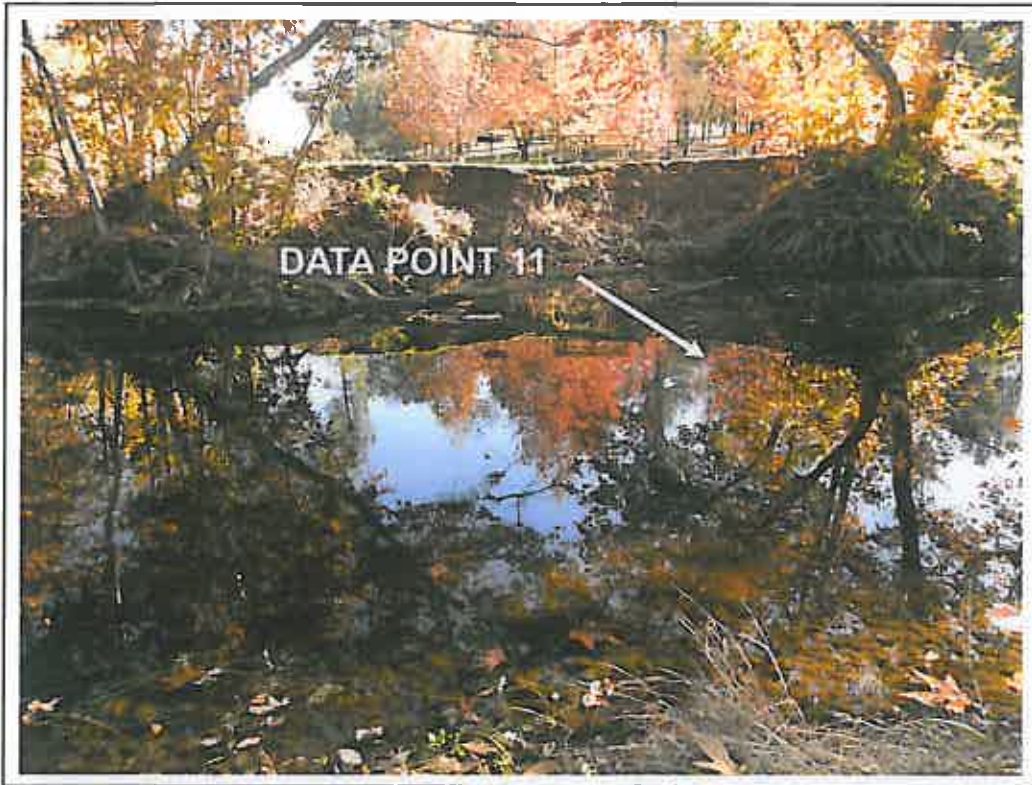
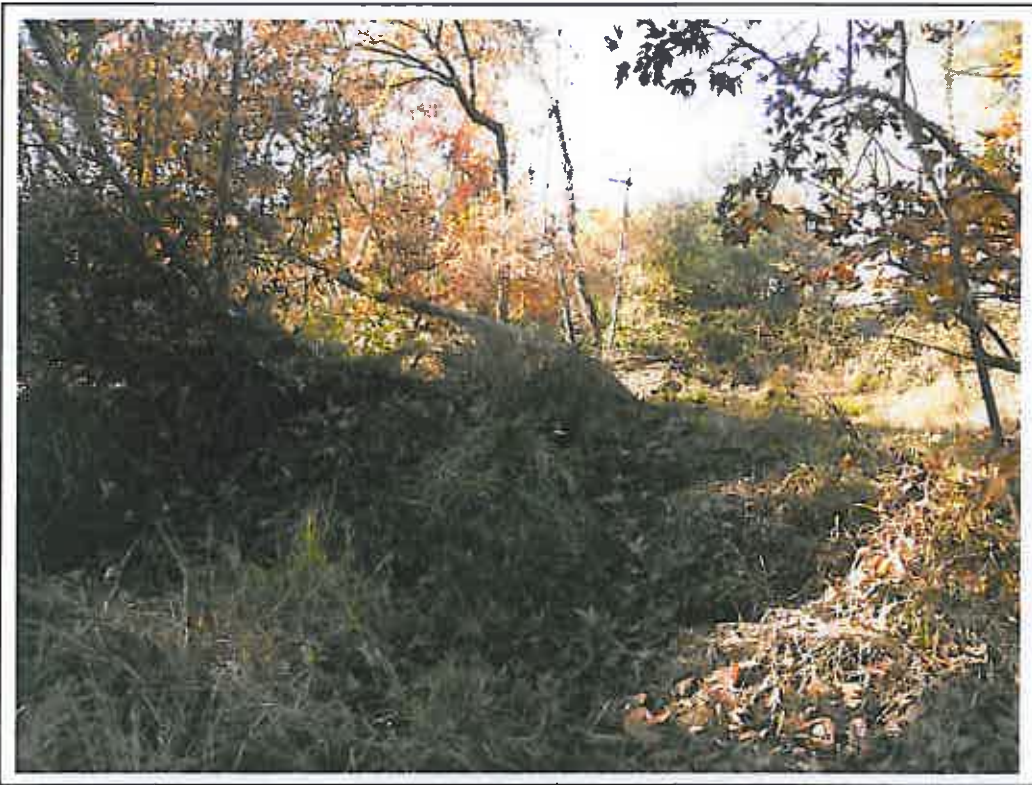
SITE: Dry Creek Tailwater Recapture Project
ITEM: Data Point 11, Dry Creek
DATE: November 21, 2012 **PLATE: 7**

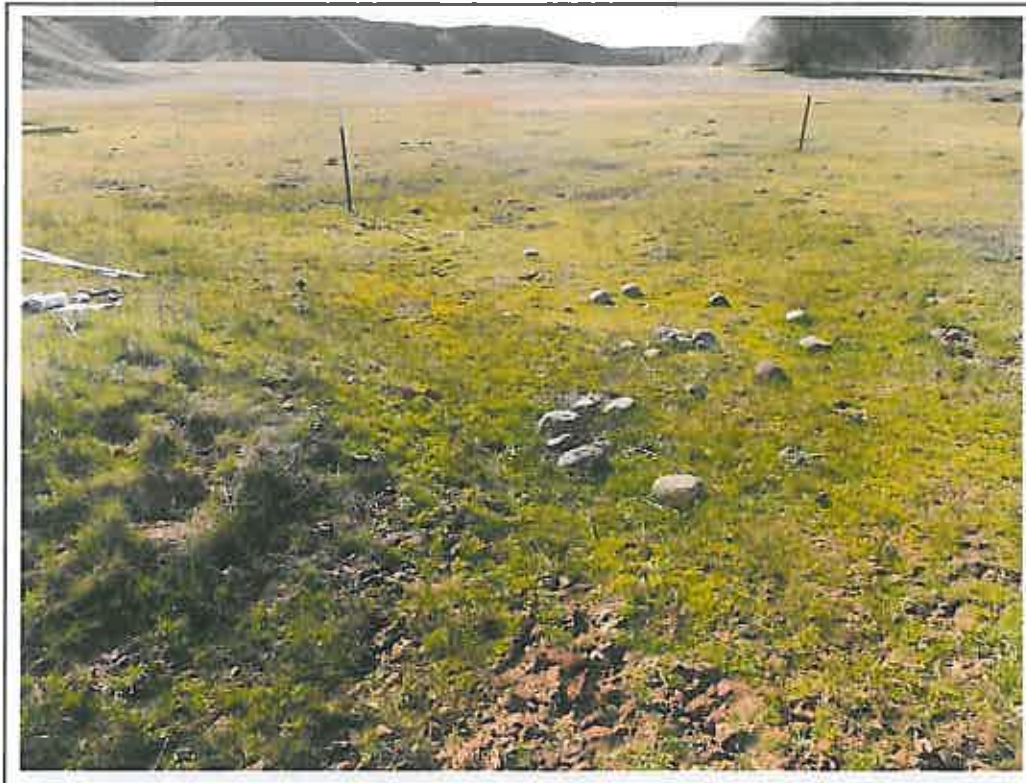
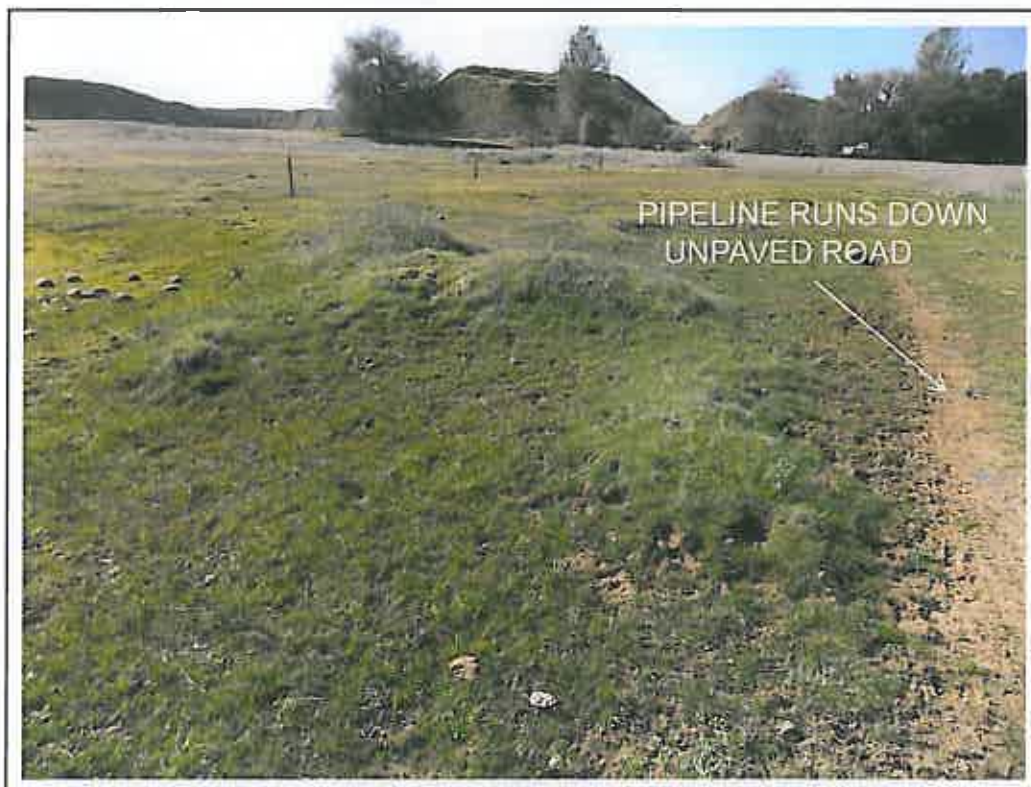
SITE: Dry Creek Tailwater Recapture Project
ITEM: Data Point 12, Seasonal Swale
DATE: February 27, 2013 **PLATE: 8**

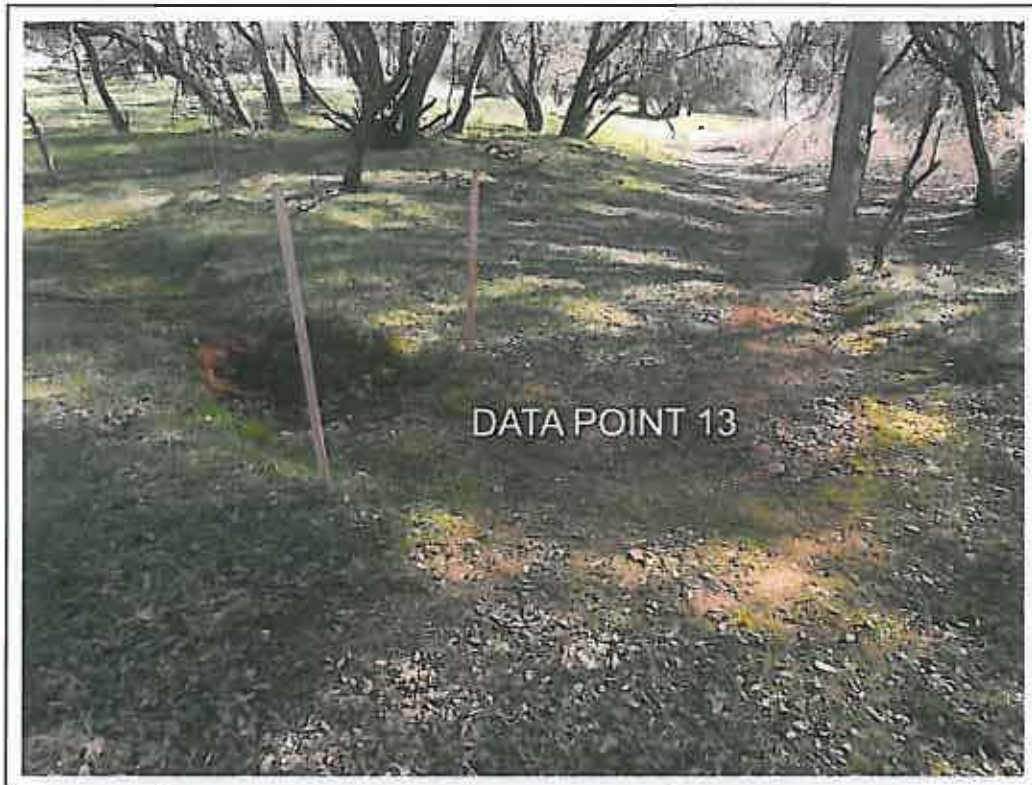
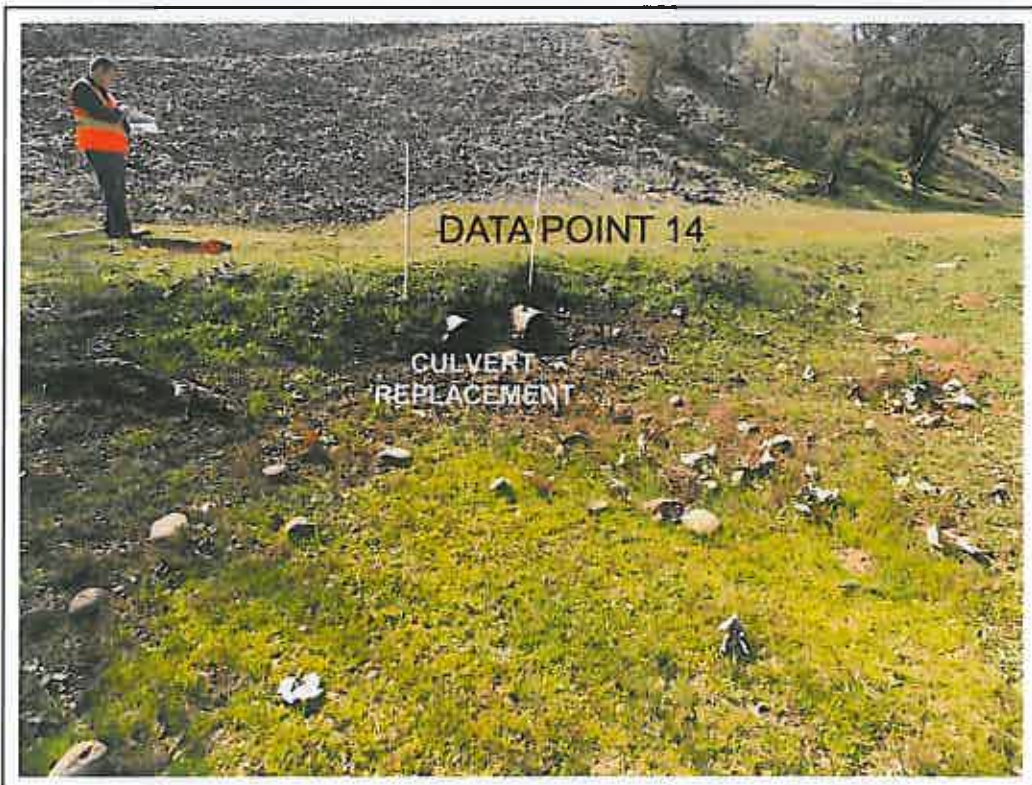
SITE: Dry Creek Tailwater Recapture Project
ITEM: Data Points 13 & 14
DATE: February 27, 2013 **PLATE: 9**

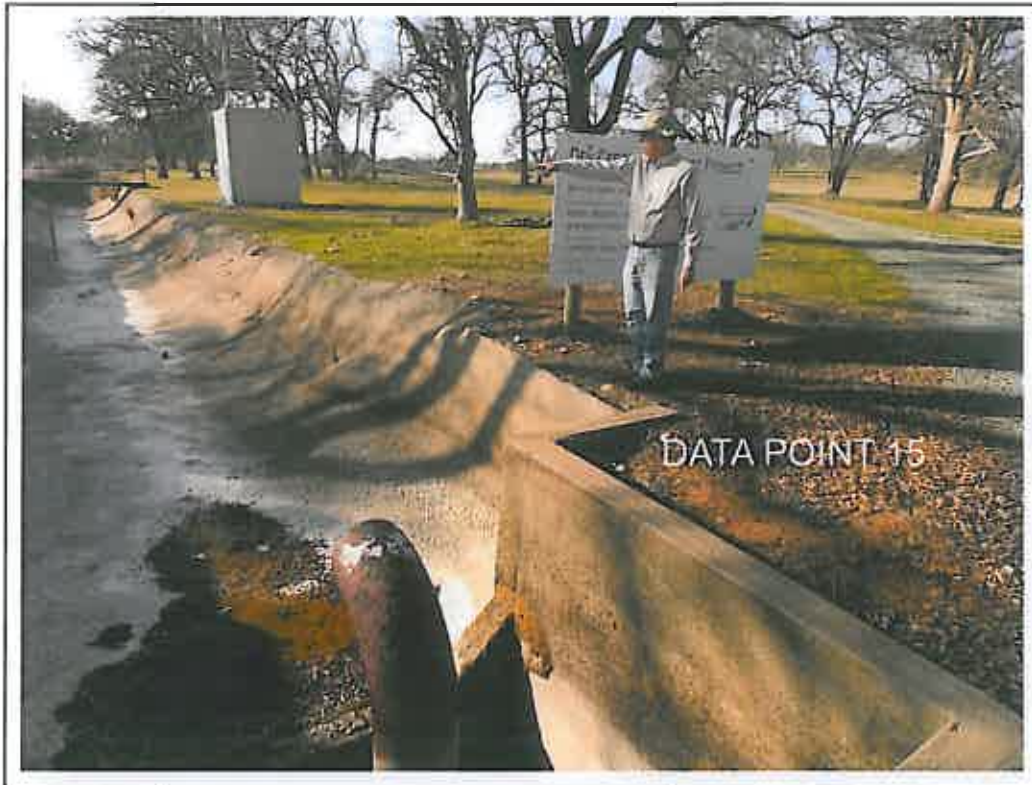
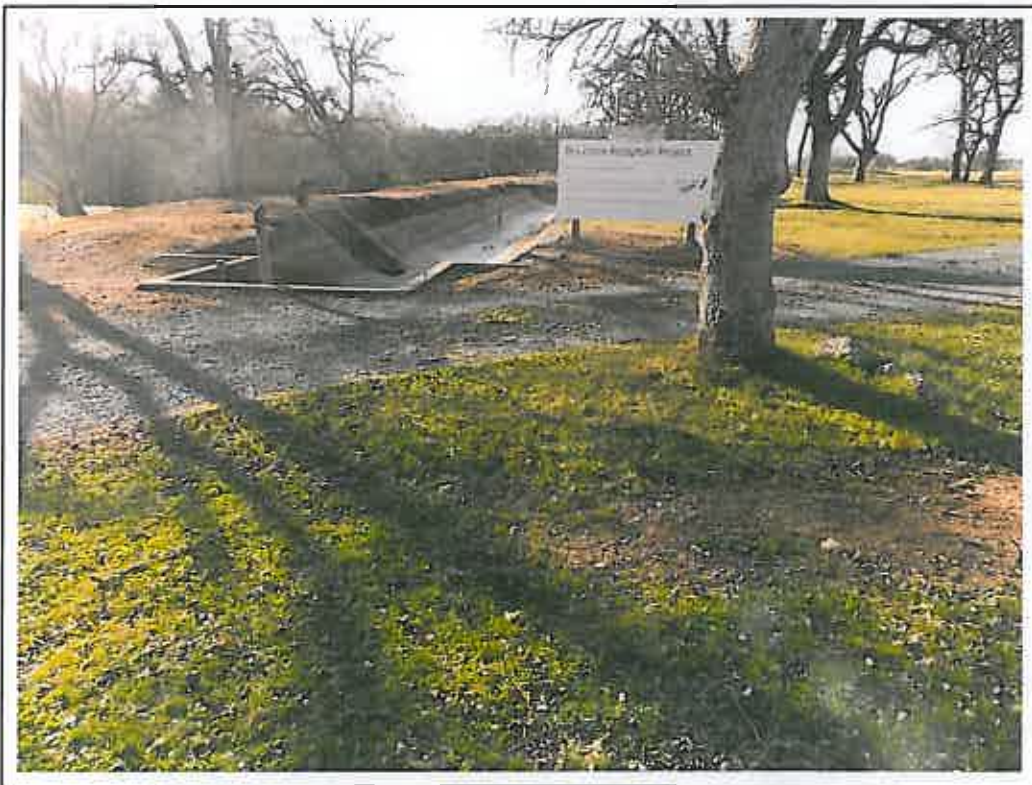
SITE: Dry Creek Tailwater Recapture Project
ITEM: Data Point 15
DATE: February 27, 2013 **PLATE: 10**

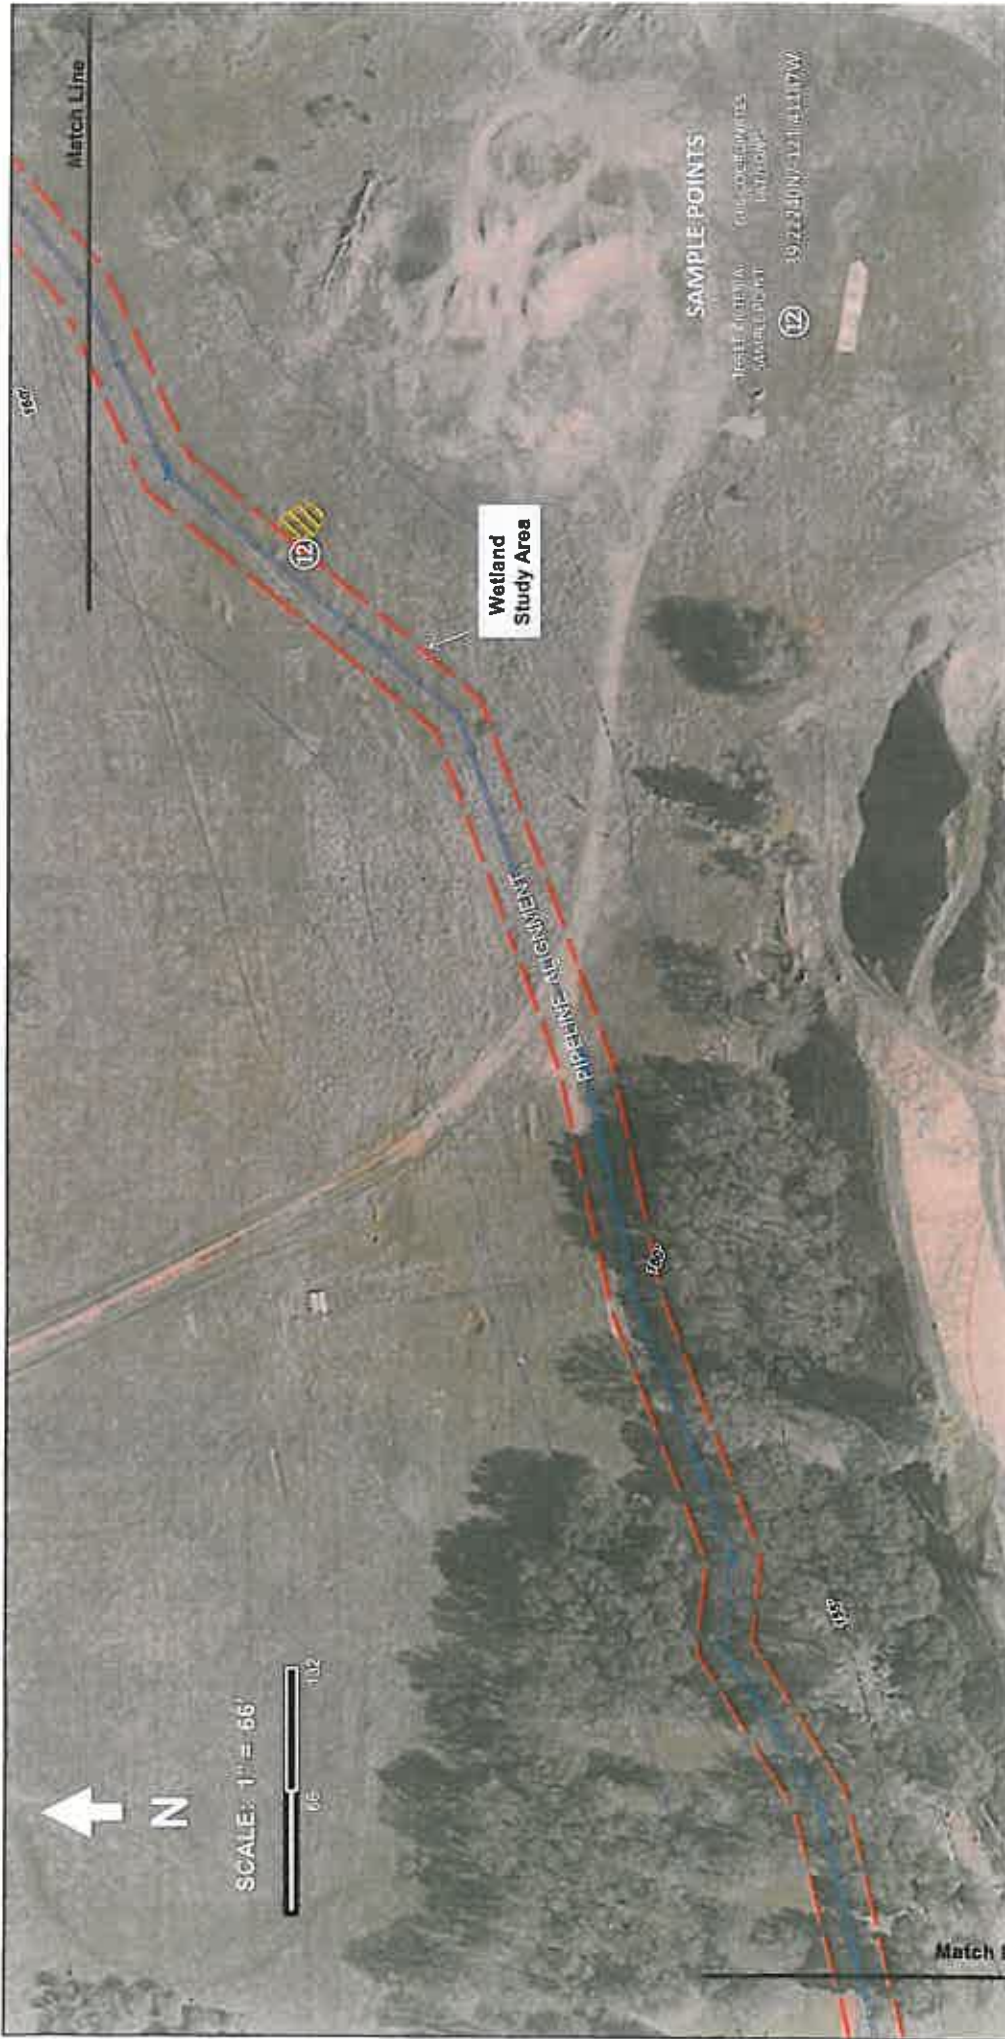
USACE Jurisdictional Delineation: Dry Creek Recapture Project

WATERS OF U.S. / TEMPORARY IMPACTS
 Data Point 12: 840 sf. / 84 sf.

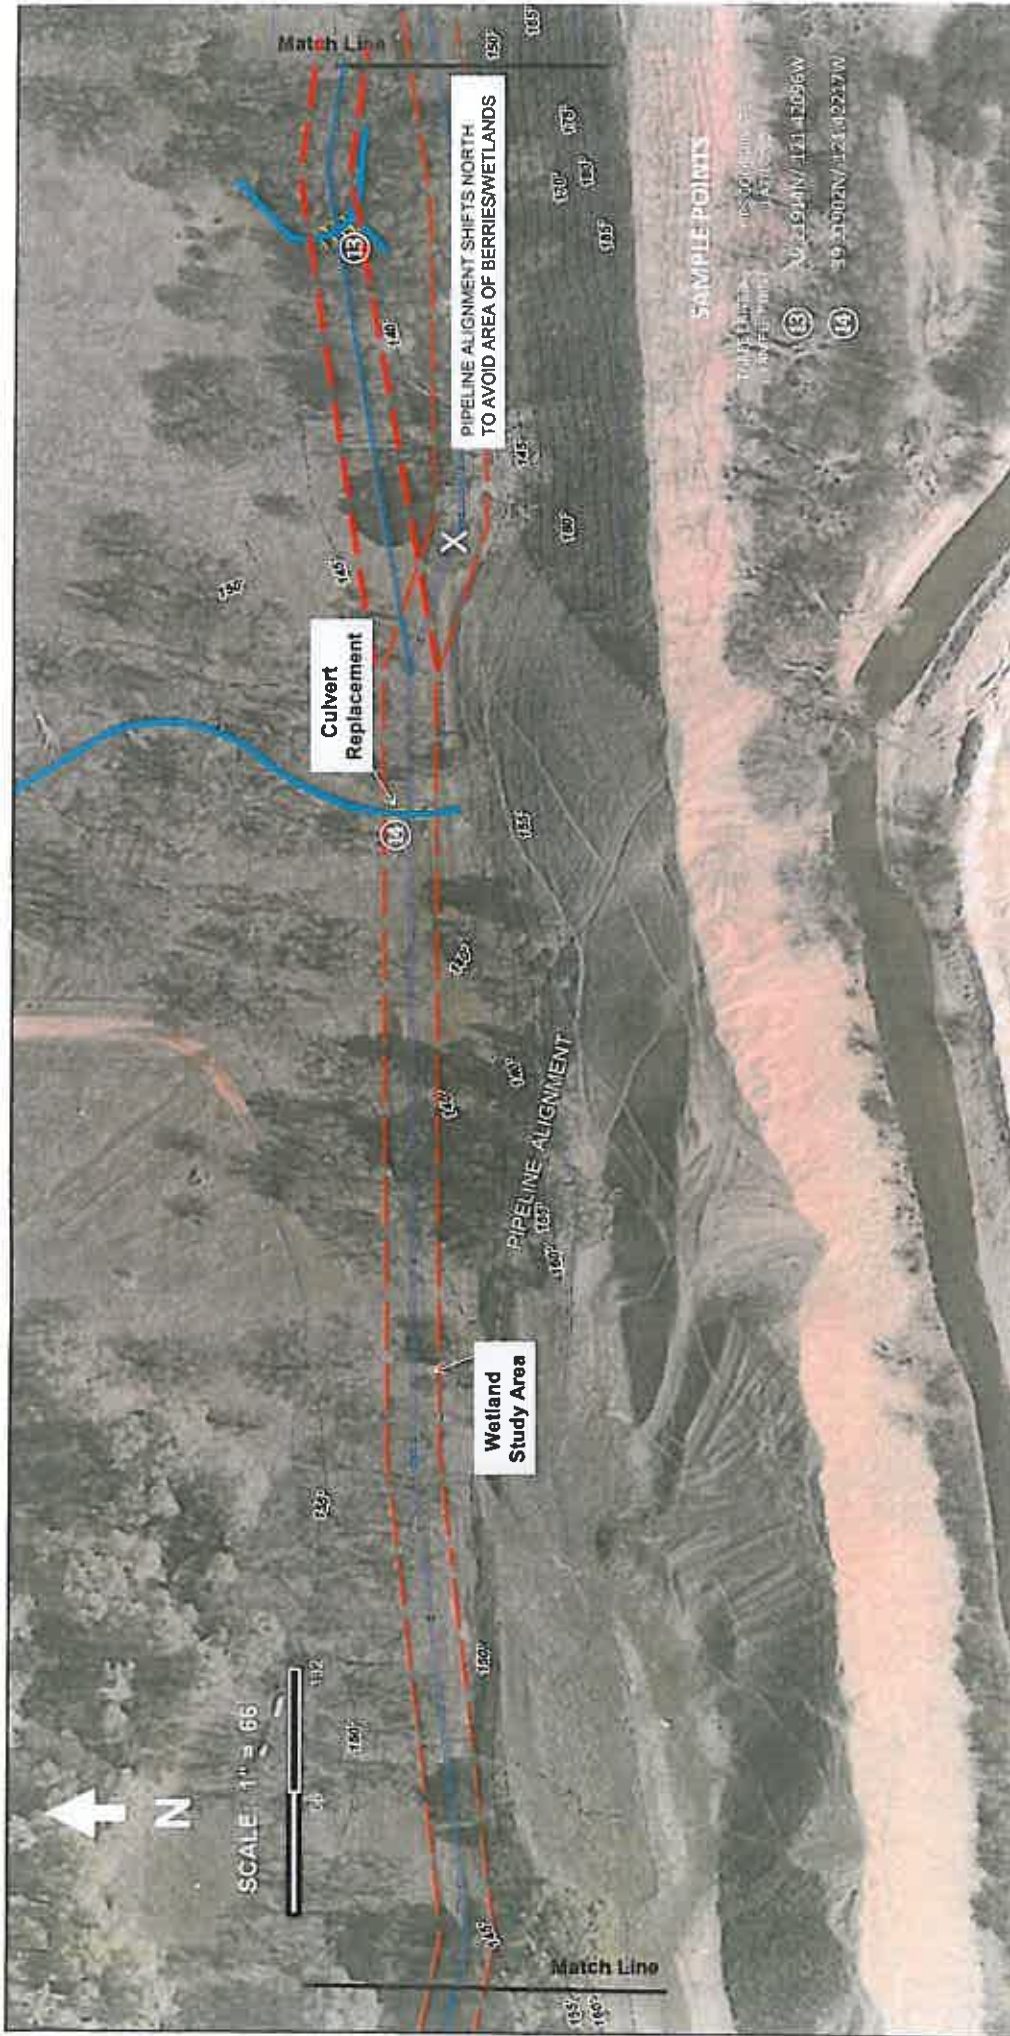
USACE Jurisdictional Delineation: Dry Creek Recapture Project

WATERS OF U.S. / TEMPORARY IMPACTS
 Data Point 13: 180 sf. / 18 sf.
 Data Point 14: 150 sf. / 25 sf.

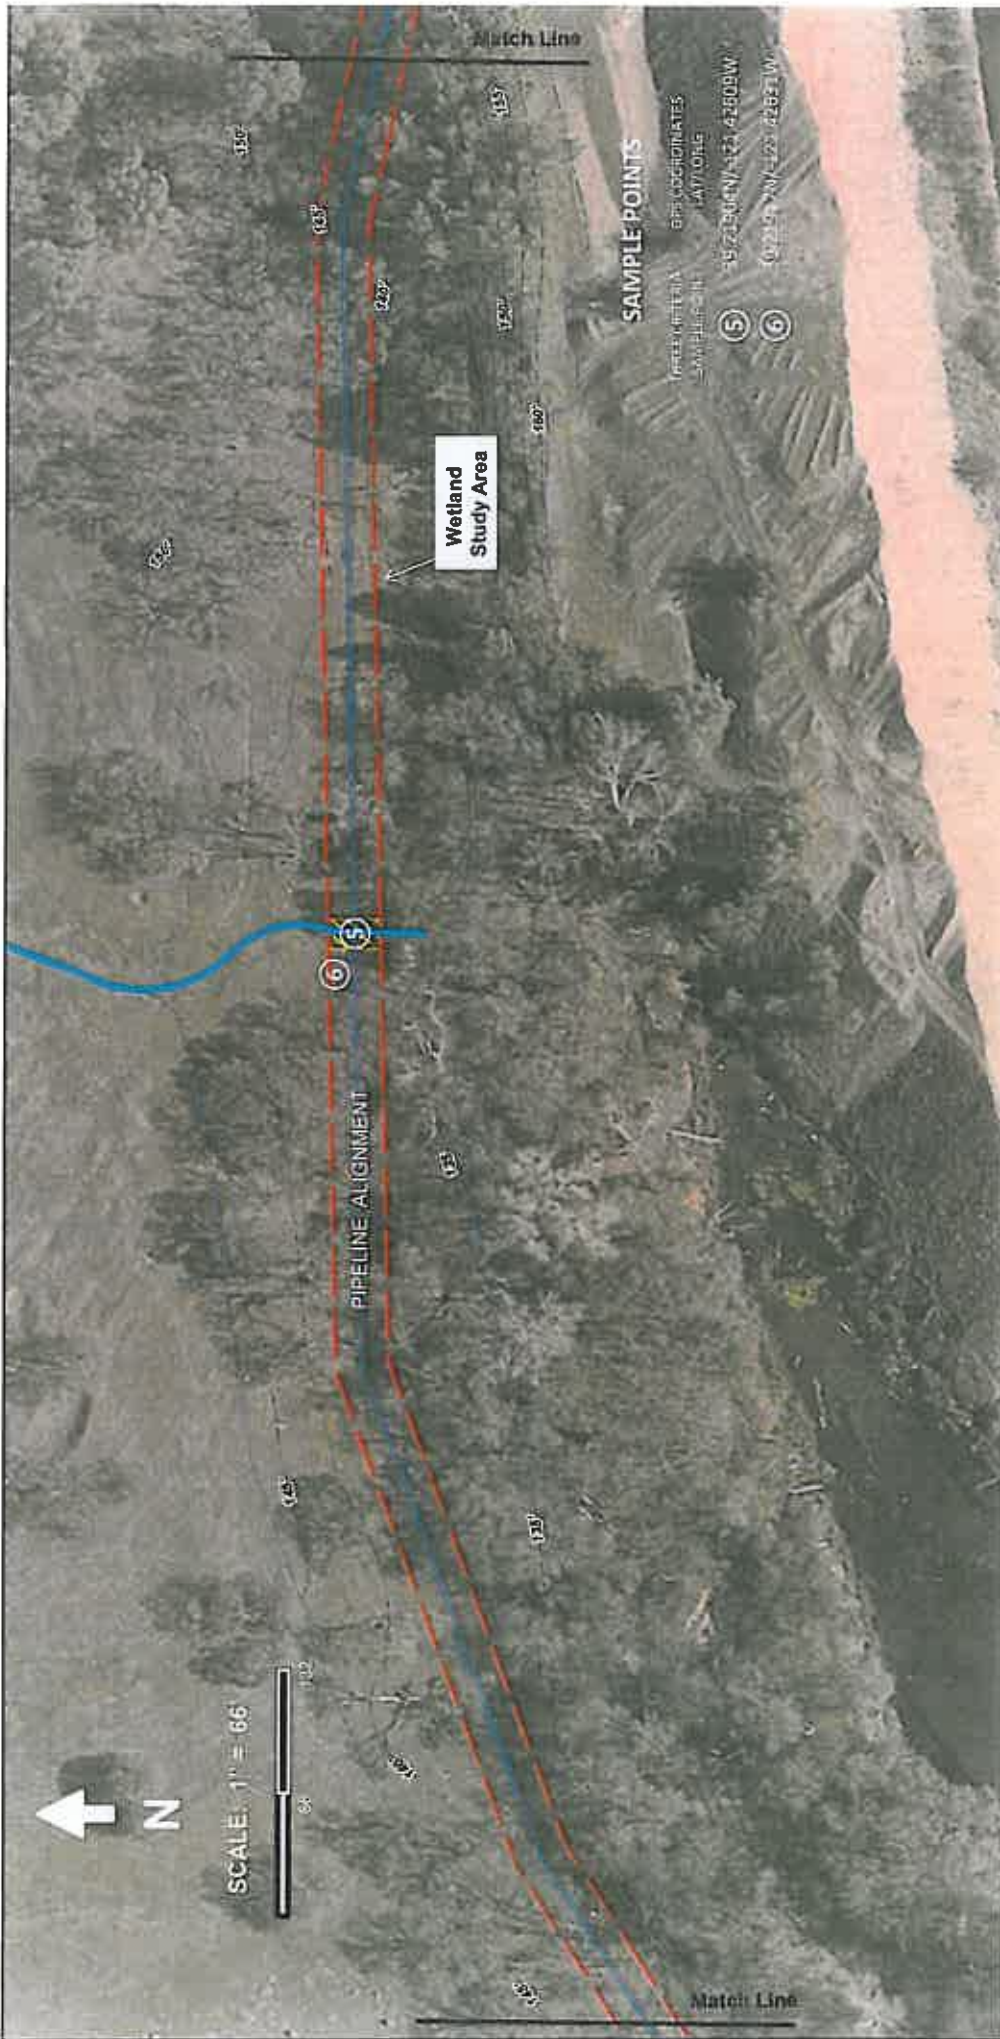
USACE Jurisdictional Delineation: Dry Creek Recapture Project

WATERS OF U.S. / TEMPORARY IMPACTS
 Data Point 5: 540 sf. / 54 sf.
