**DELINEATION OF WATERS OF THE UNITED STATES AND
BIOLOGICAL INVENTORY, 7.5± ACRE WELLAND STUDY
AREA, BROWNS VALLEY IRRIGATION DISTRICT
TAILWATER RECAPTURE PROJECT, LOCATED WITHIN
PORTIONS OF SECTIONS 21, 22, 28, AND 29, TOWNSHIP 16
NORTH, RANGE 5 EAST MDM. BROWNS VALLEY USGS
QUADRANGLE, YUBA COUNTY, CALIFORNIA 95918**

Update: March 8, 2013

**Browns Valley Irrigation District
Attn: Walter Cotter, General Manager
9370 Browns Valley School Road
Browns Valley, CA 95918**

**Marcus H. Bole & Associates
104 Brock Drive
Wheatland, CA 95692**

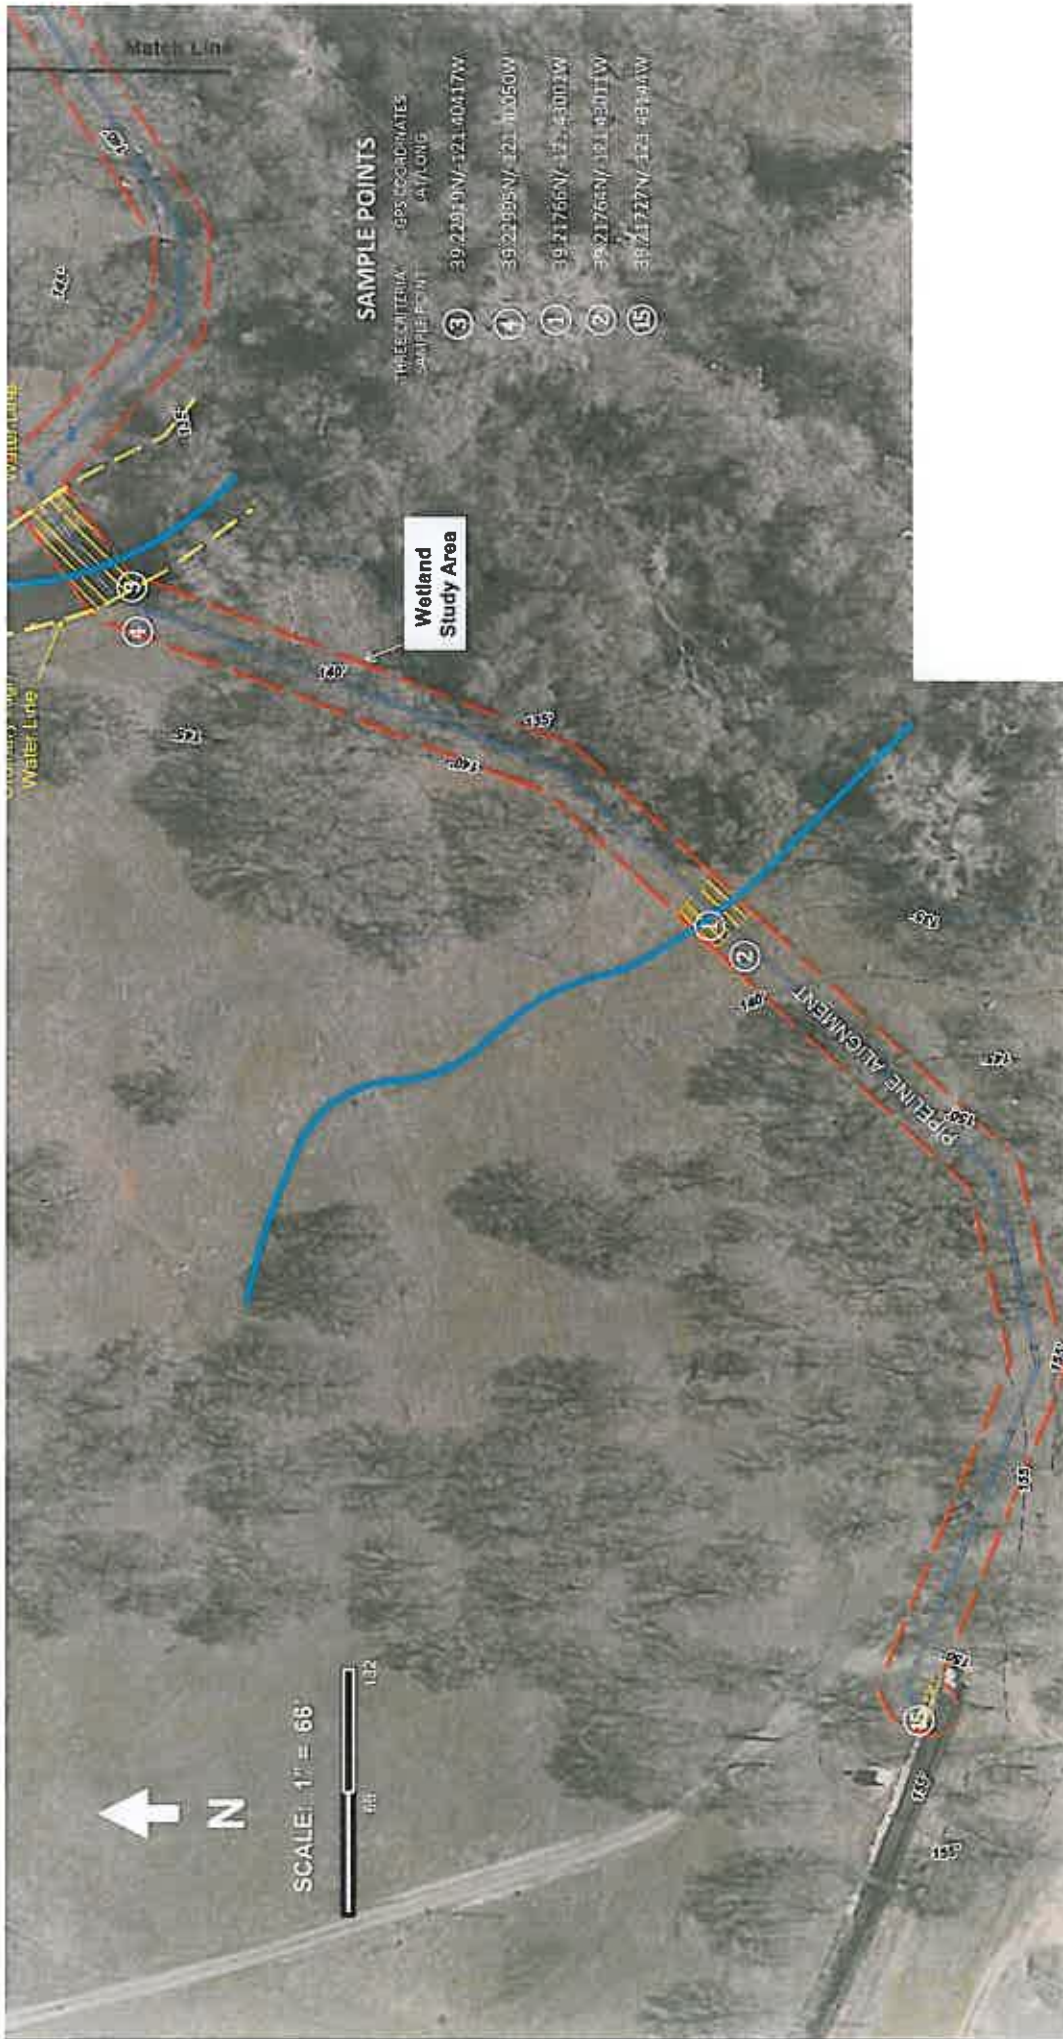
WATERS OF U.S. / TEMPORARY IMPACTS
 Data Point 3: 1,500 sf. / 150 sf.
 Data Point 1: 840 sf. / 84 sf.
 Data Point 15: 25 sf. / 25 sf.
